SUBARU BALL JOINT (N84-80126)

MARKET-REPORTED ISSUE

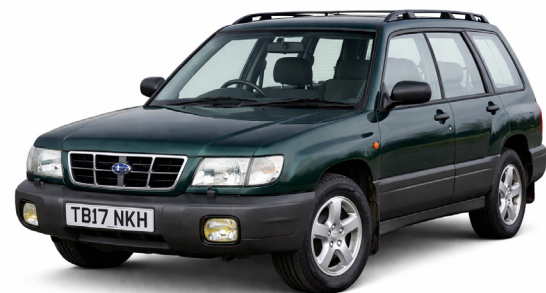
- Rust build-up inside steering knuckle bore due to road salt exposure
- The tight fit may make the part seem incorrect and can prevent proper installation
- Rust may stop the new ball joint from seating correctly

- Clean steering knuckle bore before installing replacement ball joint
- Remove all rust and scale to ensure correct seating
