REINFORCED STABILISER LINK (N66-80170)

MARKET-REPORTED ISSUE

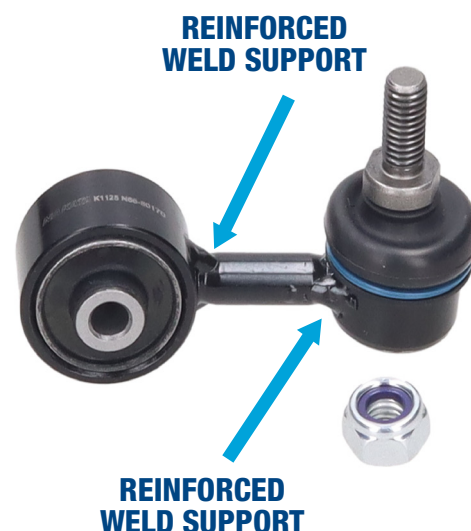
- Fracture or cracking reported
- Failures occur at known high-stress points (the weld junction)
- Risk increases with mileage, load, and road conditions
- Repeated cyclic loading causes fatigue cracks

- Reinforced weld support at the stabiliser link arm junction

- Replace stabiliser links in pairs and tighten fasteners to manufacturer specifications
